CASE STUDY / INTERVIEW

After 18 years and 15 experts, Samanalawewa Dam Turns to AquaTrack™ to Find Their Leak

The Samanalawewa dam is a 100 meter high, 530 meter long rockfill dam with a clay core; built on a karst foundation in Sri Lanka.

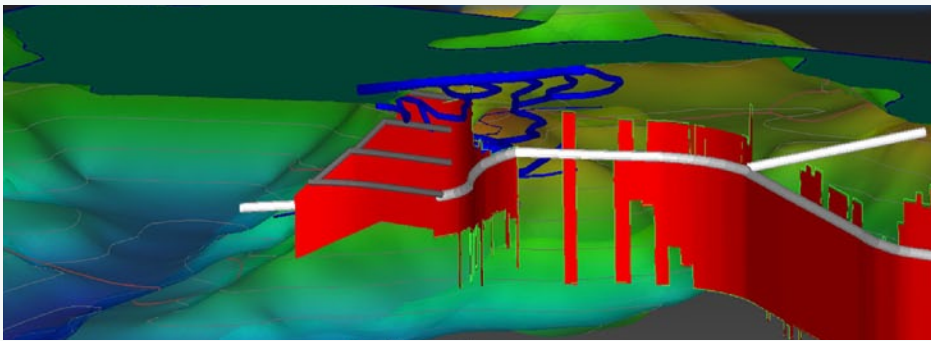
FLOWPATHS SHOWN IN 3D LOOKING UP FROM BENEATH THE RESERVOIR

“In just three weeks the Willowstick survey identified two discrete areas above the grout curtain where leakage was taking place.”
